# Winterthur Museum

### Conservation Report

**Accession #:** 2003.0032

**Object:** Clock face and movement

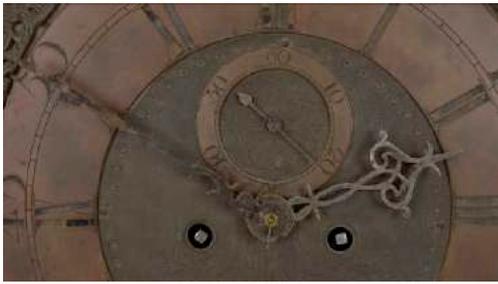
Figure 2. Detail of Chandlee clock

The steel hour, minute and second hands all have minor brown corrosion (rust) and there is significant loss to the black paint on the minute hand. The minute hand is slightly bent away from the face. In comparison with other hands on Benjamin Chandlee, Jr., clock faces, the shape and thickness of this minute hand give rise to the suspicion that it is a later addition to the Chandlee clock face or that it has been altered (see

Appendix for examples of other Chandlee clock faces). It is possible that the minute hand is original but has been flattened in response to previous damage.<sup>14</sup> Technical analysis will aim to elucidate this. There is no evidence of paint on either the hour or the second hands.

6. The hour and minute hands were surface cleaned with Stoddard solvent on cotton swabs, after testing the solubility of the black paint. Corrosion on the hour and minute hands was softened with Stoddard solvent and removed using glass bristle brushes and Grade 0000 steel wool. The hour and minute hands were brush coated with Renaissance microcrystalline wax (a mixture of Cosmolloid 80 hard and BASF A waxes). The seconds hand was not cleaned, as it was found to be blued steel via Raman analysis. While it is not known whether the hour and minute hands were blued originally, no evidence of bluing currently exists on these elements.

Through XRF analysis it was determined that the minute hand, originally thought to have been restored, was in fact uniform in elemental composition. Therefore, no treatment beyond surface cleaning was carried out.

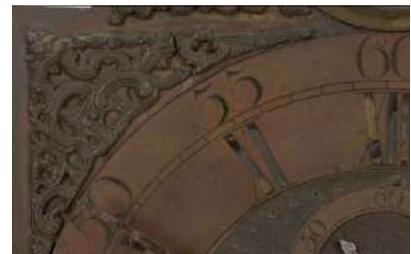
There is extensive loss of the black fill material in the engraved designs on the clock face. The most severe areas of loss are in the engraved Roman numerals (see figure 3). Minor pitting, abrasion, and surface grime are present on the fill material in the engraved Arabic numerals (on the chapter ring and seconds ring) and also in the script of the nameplate.

Figure 3. Detail of loss to black fill material and broken spandrel

The proper right spandrel ornament in the upper corner of the faceplate is broken into two pieces, but both remain attached to the faceplate with steel pins and screws that appear to be historic repairs to the spandrel. The break is located above minute “55” on the chapter ring.

7. Through FTIR and GC-MS analysis the black fill material in the numerals on the chapter ring, seconds ring, and nameplate was found to be a mixture of carbon black, pine resin and beeswax. Solubility testing determined that the black material softened in acetone, ethanol, Shell Sol, and toluene. The black fill material was found to be least immediately soluble in water and mineral spirits.

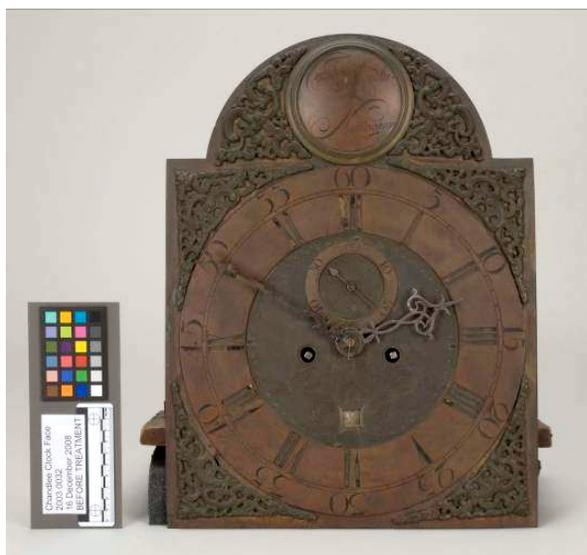
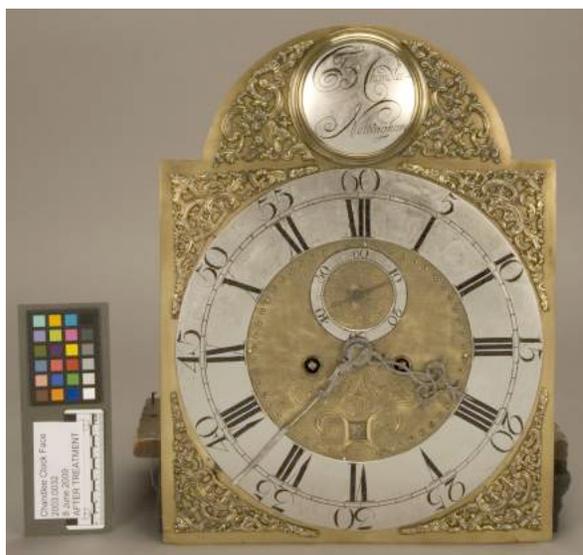
The Chandlee clock face before and after treatment.

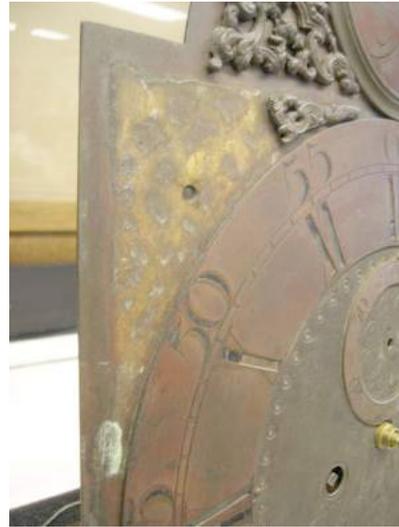
Detail of faceplate after the upper proper right spandrel decoration has been removed. Note the piece of the spandrel decoration that remains attached.

4. In preparation for corrosion removal, the faceplate, central stippled field, and spandrel ornaments were additionally surface cleaned using 1-methyl-2-pyrrolidinone and acetone. With GC-MS analysis, the corrosion on the faceplate was found to be embedded in layers of carnauba wax. It had been found through FTIR and GC-MS analysis that the spandrel decorations were coated with an untinted pine resin coating. The pine resin coating on the spandrel ornaments was removed during this step, because in order to remove the corrosion from the spandrels, this coating, now embedded with corrosion, had to be removed. Remnants of coatings and corrosion were left on a small area on the broken segment of the upper proper right spandrel decoration.

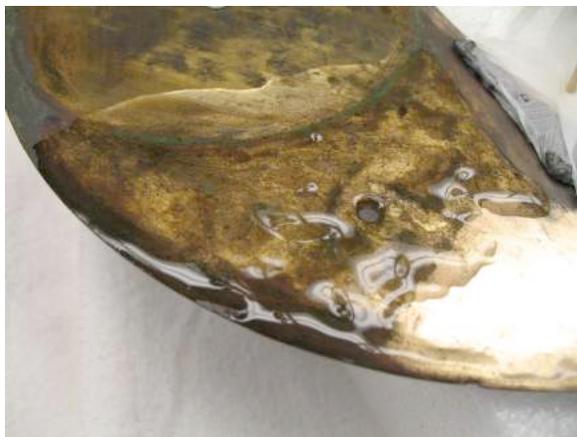
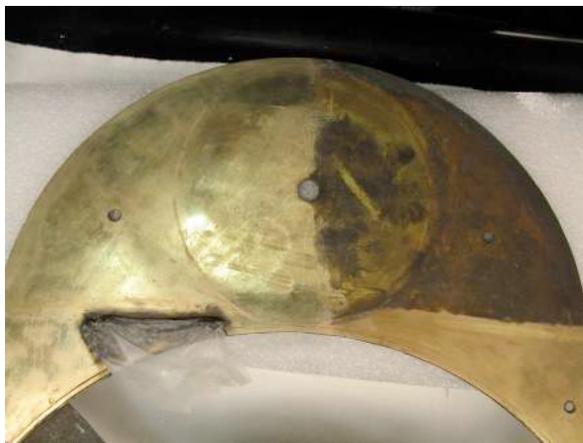
Left: Lunette of faceplate with citrate gel in place. Corrosion has been removed in the bright area at the far right.

Right: Lunette of faceplate after half has been cleaned with citrate gel.

For corrosion removal on the faceplate and central stippled plate, mechanical methods alone did not reduce the corrosion. Upon consultation and testing with Richard Wolbers, a 2% citric acid gel (pH=3, pH raised using triethanolamine) was found to most effectively remove the corrosion. The gel was applied to a small area, left for a few minutes, removed with a cotton swab, and the area was cleaned used

1-methyl-2-pyrrolidinone, followed by acetone. This process was repeated until the corrosion had been reduced to a thin, pink-colored layer. It was thought that this pink layer was a remnant of the red corrosion (cuprite,  $\text{Cu}_2\text{O}$ ) present on the faceplate. Please see Appendix for a discussion about acid cleaning and possible dezincification or redeposition of copper.

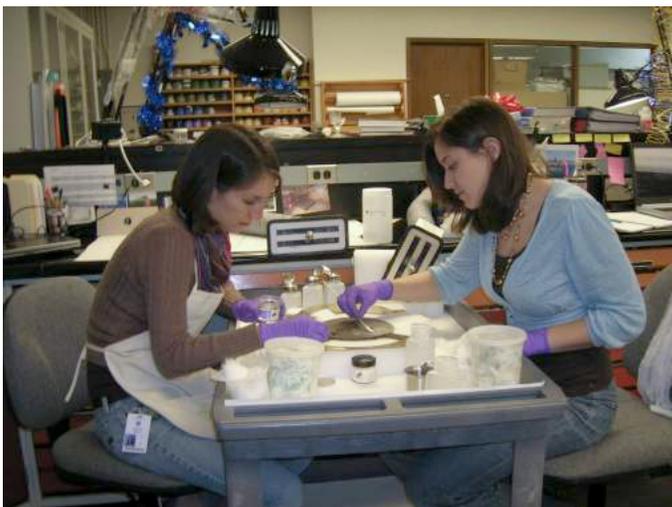
Left: Removing corrosion from the central stippled field.

Right: Stippled central field during treatment.

The central stippled field underwent additional treatment using Autosol Metal Polish® (aluminum oxide powder dispersed in an aqueous soap solution) and Nev-Dull® (aluminum oxide and calcium carbonate dispersed in mineral spirits) wadding polish to help reveal the brass and reduce the pink appearance of the metal. These materials were used as a last resort when no other methods reduced the “pink” layers to a satisfactory appearance.

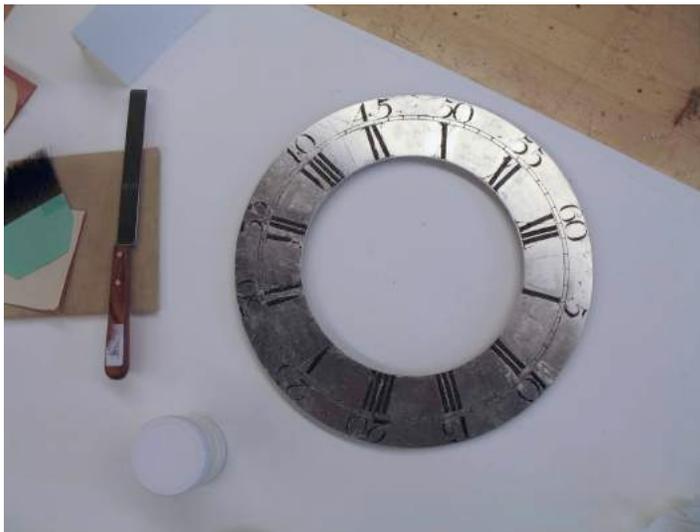
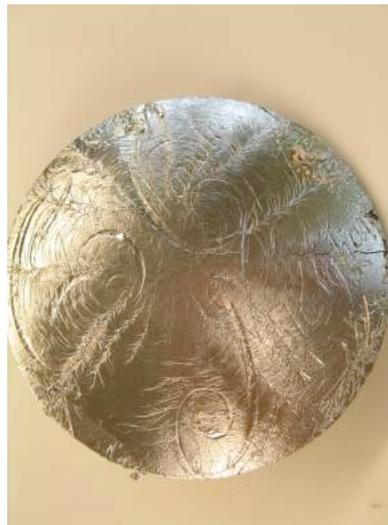
Left: The chapter ring after gilding with palladium leaf

Right: The nameplate after gilding with palladium leaf, before the leaf has been wiped away in the letters.

Through discussions with curators Ann Wagner and Wendy Cooper, it was decided to recreate the silvered appearance on the chapter ring, seconds ring, and nameplate by gilding with palladium leaf. The palladium leaf was chosen because: it is darker in appearance compared to silver leaf, and thus more closely resembles other clocks in the Winterthur collection; in the future, palladium will not be confused as an original material; and palladium is a more stable metal than silver, and it will be less likely to corrode or tarnish. Rolco Aquasize, (a water soluble acrylic emulsion composed of an acrylic copolymer (45%), drying additives (0.2%), flow and foam additives (2.8%), and water (52%), was used as a sizing medium for the palladium

leaf. The sizing medium came to tack within one hour. The leaf was applied to the chapter ring, seconds ring, and nameplate using a gilder's tip.
