# Winterthur Museum

### Conservation Report

**Accession #:** 2003.0032

**Object:** Clock face and movement

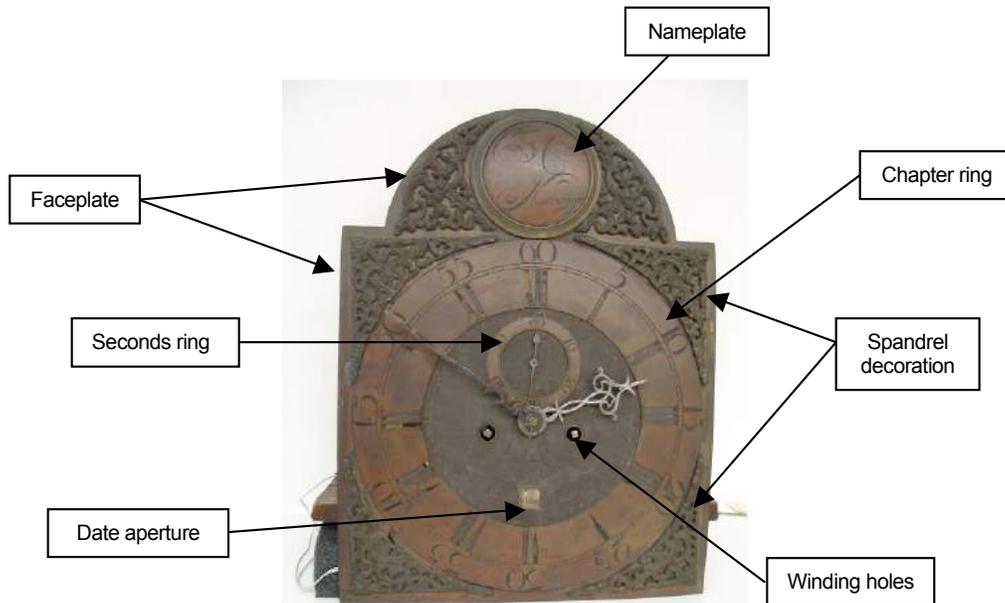
Figure 1. Chandlee clock face, 2003.0032

On the front of the clock face, all brass elements (faceplate, spandrel decoration, stippled central plate, chapter ring, nameplate, and seconds ring) suffer from corrosion. On the faceplate there is red, brown, and light green corrosion around the edges. The spandrel decoration and the stippled central plate have a dark brownish-green patina. In the crevices of the spandrel decoration and around the edges where the decoration meets the faceplate are tiny amounts of light green powdery corrosion. The chapter ring, seconds ring, and the nameplate currently are similar in appearance and are reddish in color, possibly a result of dezincification of the brass. These three elements would have most likely been silvered, but there is no visible sign of any silver at this time. Loss of silvering could have occurred as a result of chemical or physical cleaning of the thin, silvered surface. Dezincification could have occurred if highly alkaline or acidic solutions were subsequently used to clean the exposed brass. The calendar ring is less corroded on the front than other elements, but it is scratched.

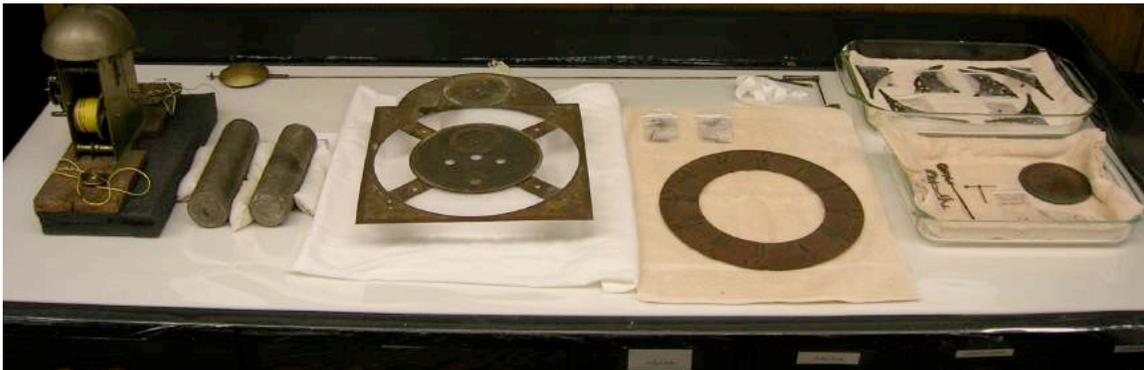
The clock face disassembled into its various components. Note that the seconds ring is still attached, but was later removed.
